ALABAMA HAZARDOUS WASTES MANAGEMENT AND MINIMIZATION ACT (AHWMMA)

Compliance Evaluation Inspection (CEI) Report

Chemical Waste Management, Inc. (CWM)
36964 Alabama Highway 17 North
Emelle (Sumter County), Alabama 35459

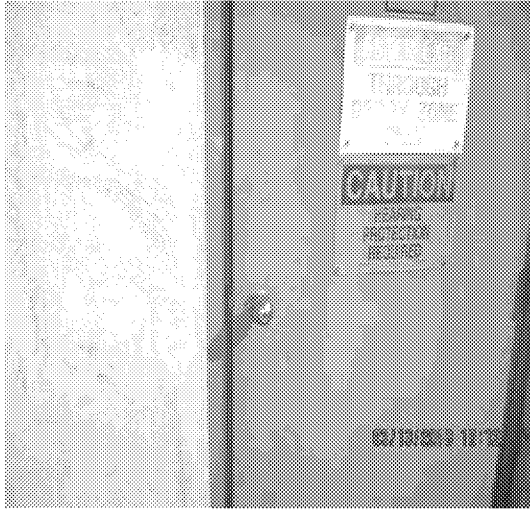
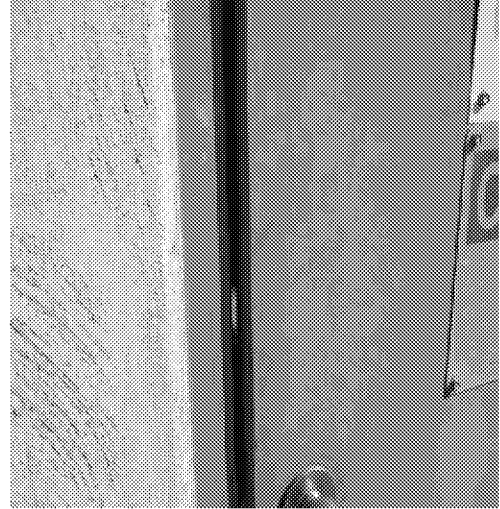
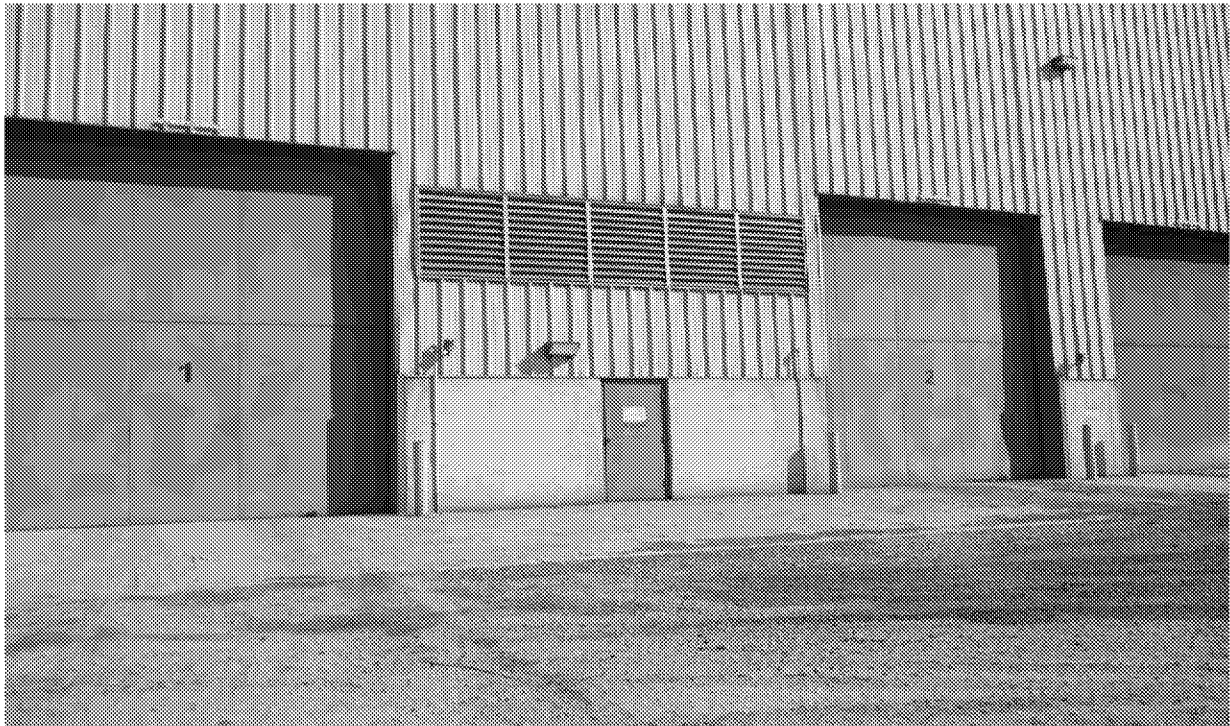
Building 1200A Personnel Door

One personnel door leading into the containment building could not be closed entirely (See Attachment B). Facility personnel were informed of this area of concern at the time of the inspection.

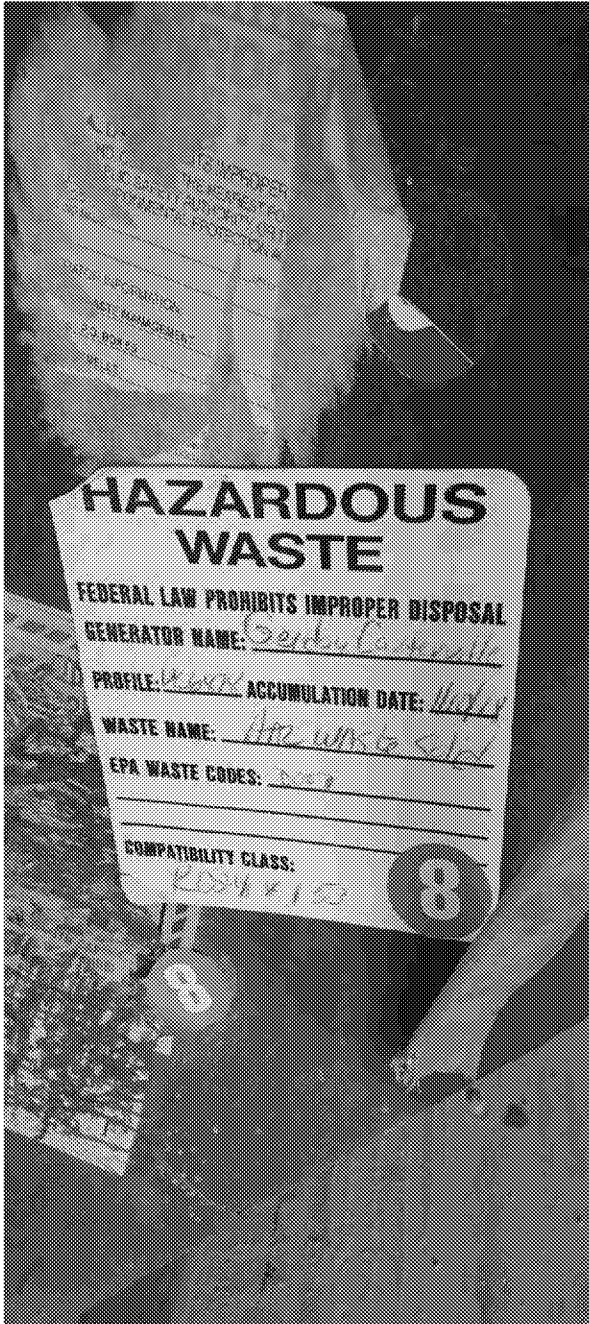
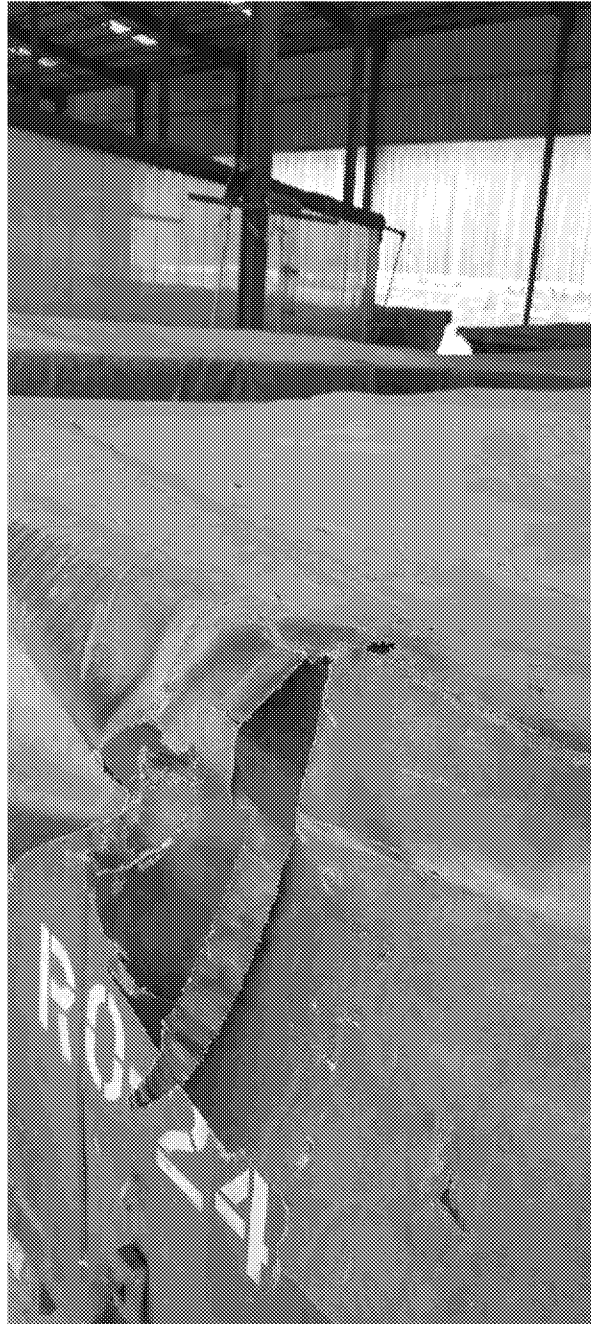
- 1) Roll-off RO24 had a torn tarp and was not considered closed (See Attachment A).
- 2) Roll-off RO25 had a tarp that was not sufficient to be used as a cover, so the container was not considered closed (See Attachment A).

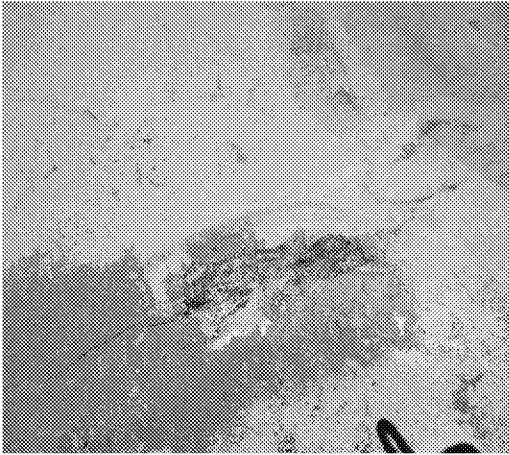
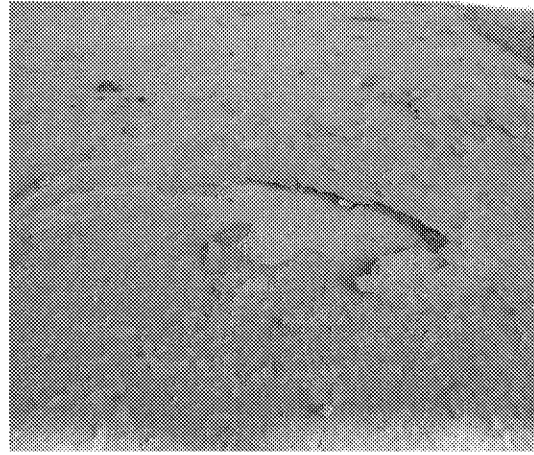
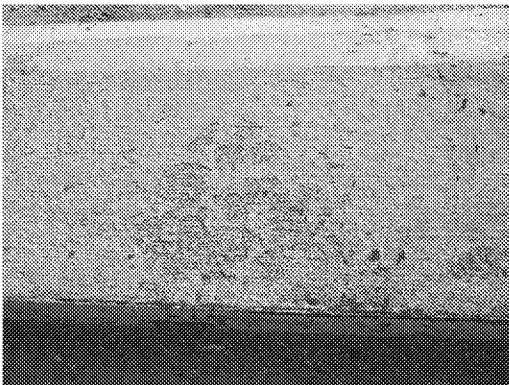
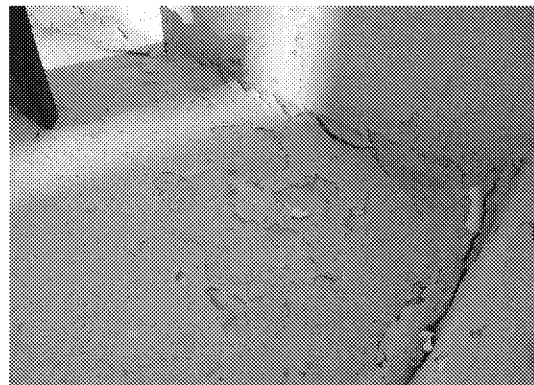
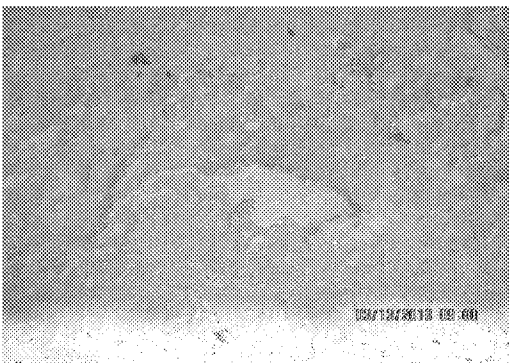
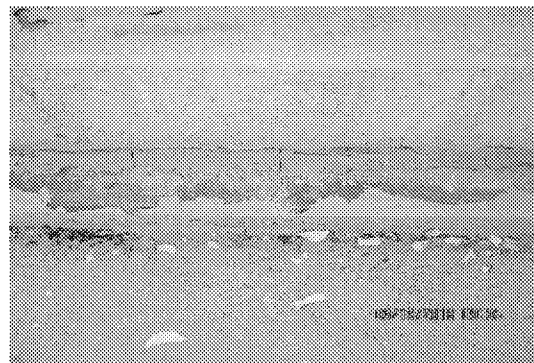
Tank Farm 1400 Secondary Containment

The chemical-resistant coating on the secondary containment structures surrounding and underlying the tank farm and the loading / unloading area was worn away and chipped in several areas (See Attachment B). This was noted as an area of concern at the time of the inspection. Facility personnel were aware of the damage to the secondary containment coating. A remedial work order (RWO#05550) to recoat the area was opened on July 26, 2017.

- One 20-yard roll-off (RO28) located in Building 2200 was not labeled with an accumulation start date. This was corrected during the inspection.
- The secondary containment for Tank Farm 1400 is chipped and damaged. RWO#05550, which was issued on July 26, 2017, addresses the secondary containment.

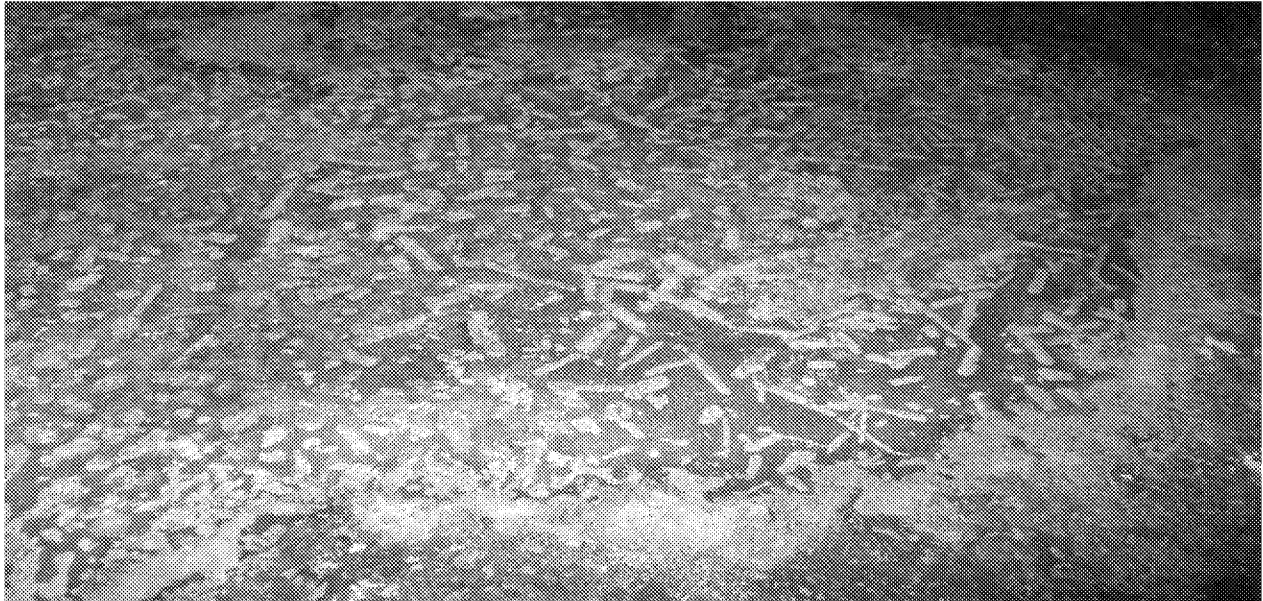
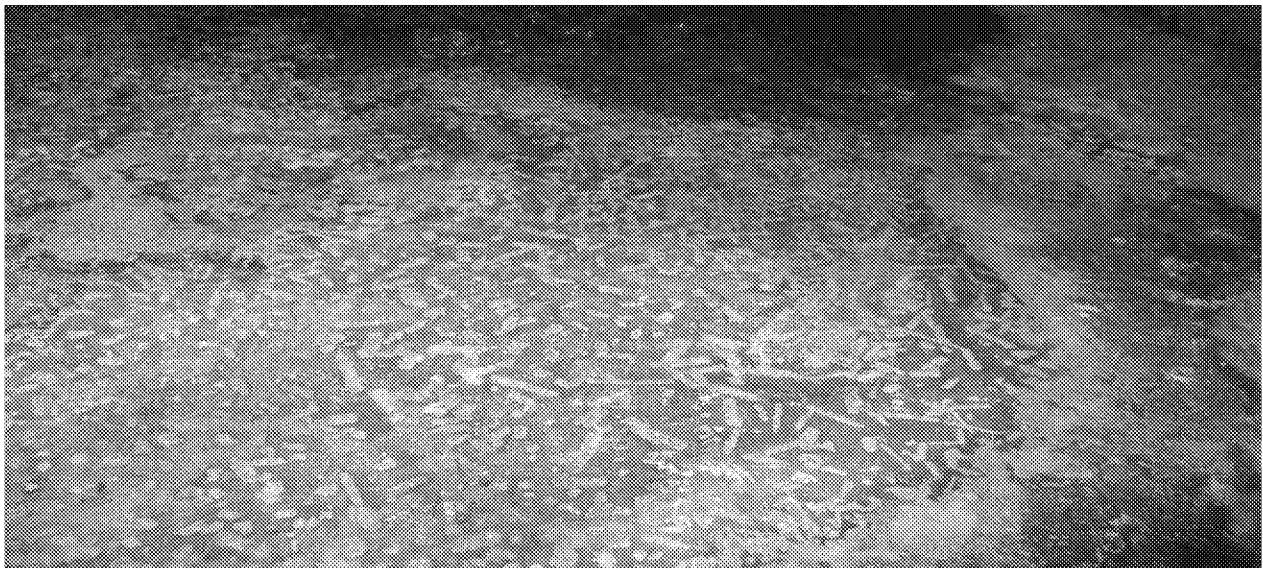
Building 1700 Residue from a Spill / Release of Leachate

Residue from a spill / release of leachate (See Attachment B) was observed on the floor of the building (within the secondary containment structure). The spill apparently occurred approximately one year before the date of the inspection (the work order to clean up the release - RWO#04964 - was opened on 3-15-17). The amount of time taken to clean up the spill was noted as an area of concern at the time of the inspection. Facility personnel cleaned up the residue and closed the work order during the inspection.

- Residue from a leak or spill located in the secondary containment of Building 1700 had not been removed in a timely manner. RWO#04965 was opened on March 15, 2017, and the residue had not been removed at the time inspection. The residue was removed after the inspection of Building 1700 by the end of the second day.
